# GRUNT/CREAK/CHIRP/SQUEAK NOISE FROM THE FRONT LOWER CONTROL ARM OVER BUMPS

TSB 13-7-8

**FORD:**  
2011-2014 Mustang

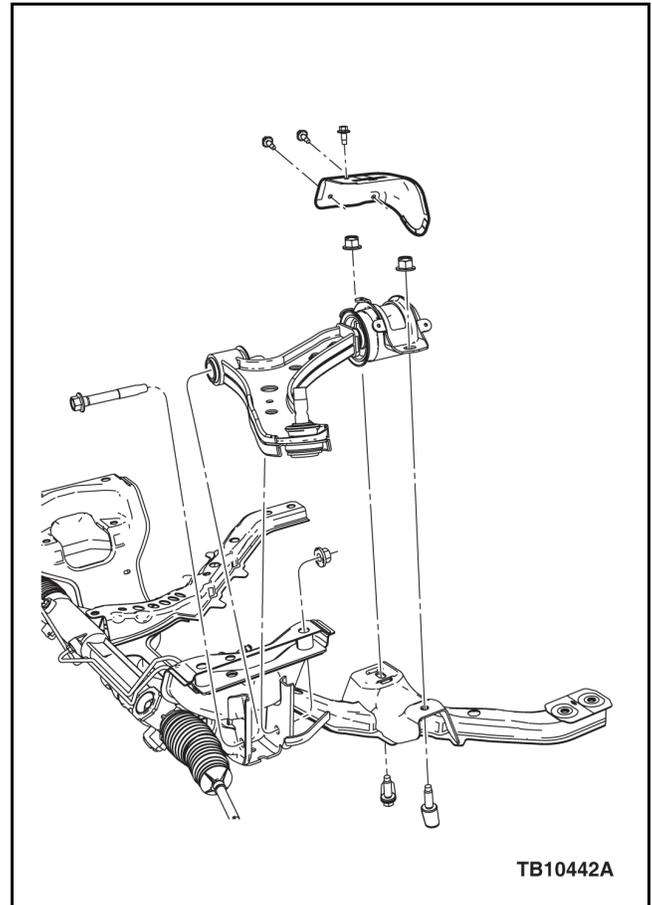
Figure 1 - Article 13-7-8

Some 2011-2014 Mustangs vehicles may exhibit a grunt/creak/chirp/squeak noise from the front lower control arm hydro bushing. These noises may occur over large vertical bumps like speed bumps, pot holes, rough roads and driveway approaches.

1. Attach Rotunda wireless chassis ears (JSP97202) or equivalent on both lower control arm hydro bushing bracket tabs to verify noise is coming from the hydro bushing.
  - a. The hydro bushing is the large diameter bushing at the rear of the control arm. Due to hydraulic fluid flow some noise from the bushing is normal. There would typically be some difference from side to side on a unit with a noisy control arm.
2. If the noise is not confirmed as coming from the hydro bushing, this article does not apply, refer to Workshop Manual (WSM), Section 204-00 for normal diagnostics.
3. If the noise is confirmed as coming from the hydro bushing, replace the affected lower control arm with the new lower control arm with shield and 3 screws. Tighten the three (3) shield screws to 7 N•m (62 lb-in.) Refer to WSM, Section 204-01. (Figure 1)
